HIGHWAY ACCIDENT REPORT

INTERSTATE BUS--AUTOMOBILE COLLISION

INTERSTATE ROUTE 15

Baker, California

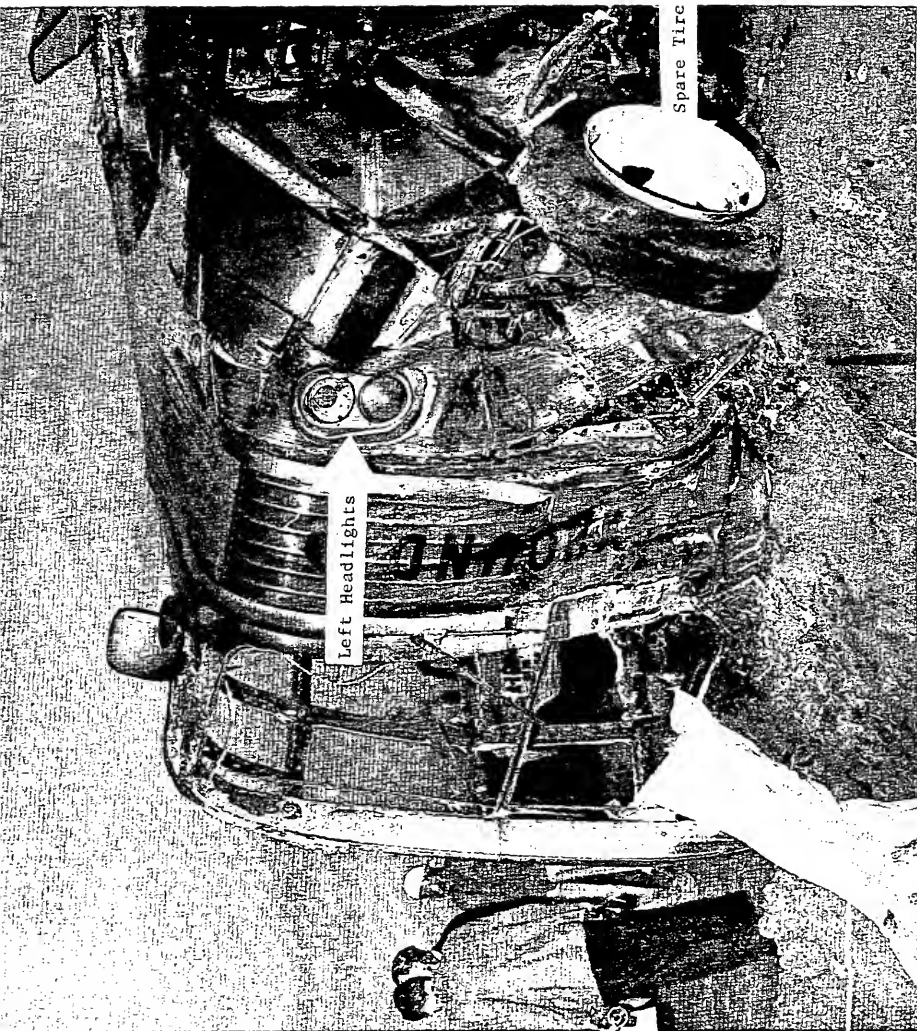
ILLUSTRATION 1

The bus and automobile collided head-on as indicated by damage to the front of the bus from its left headlights through the right front corner (Illustration 1), and to the frontal area of the automobile.

The front of the bus was severely damaged by the impact in increasing severity from the left through its right front corner, primarily in the area below its windshield. The right front wheel assembly, including suspension members, was pushed rearward through a bulkhead, penetrating and compressing the fuel tank (located immediately to the rear of the right front wheel well), and contributing to damage and distortion of the plywood floor of the passenger compartment. The fuel tank contained approximately 115 gallons of diesel fuel. The battery compartment, which was located immediately to the rear of the fuel tank, was also partially crushed and displaced. Both sections of the windshield were ejected from their mountings upon impact. The overturning motion of the bus did not contribute materially to further mechanical damage to the bus. The seats were not dislodged from their floor anchorages as a result of the collision.

Damage to front of bus from left headlights through right front corner.

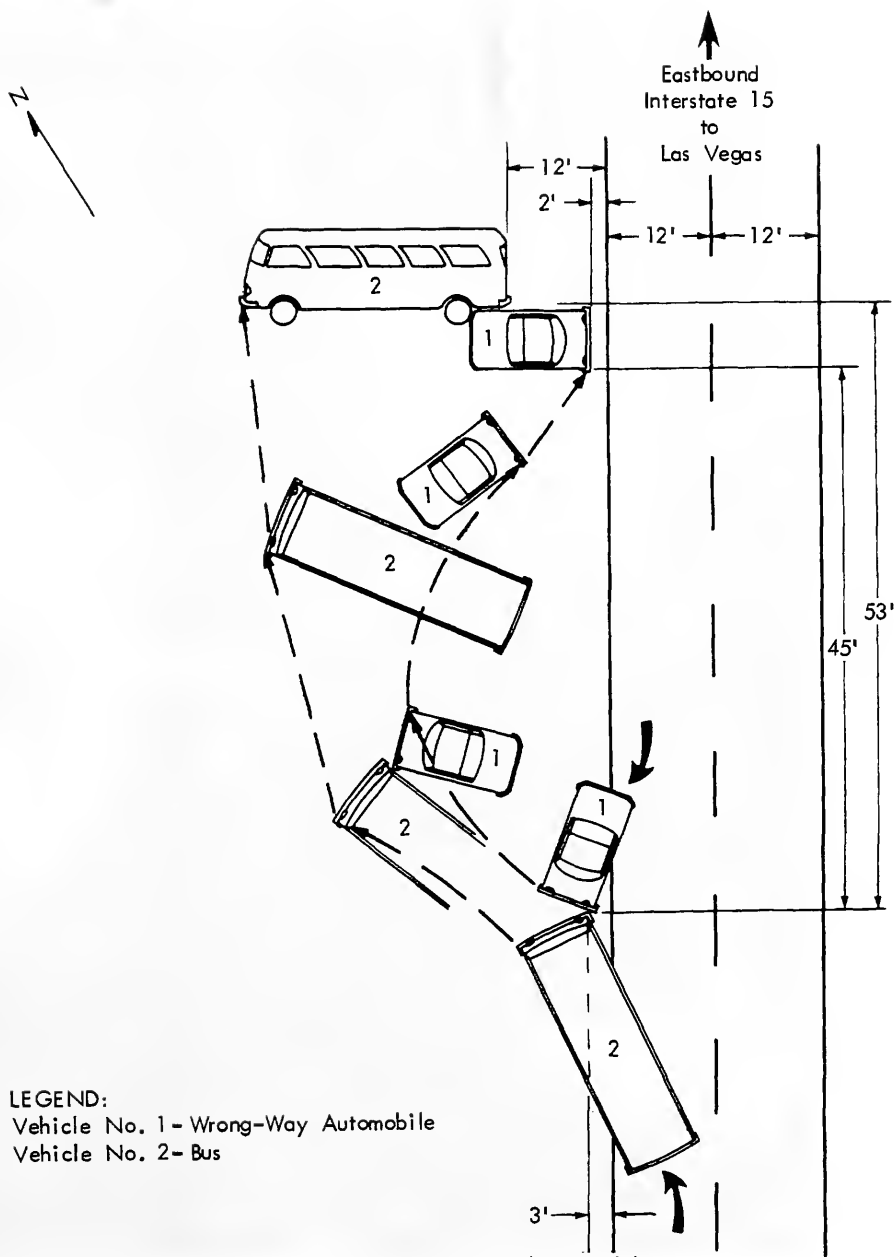
ILLUSTRATION 2 (No Scale)

Accident diagram showing relative vehicle position during collision and post-collision phases of accident.

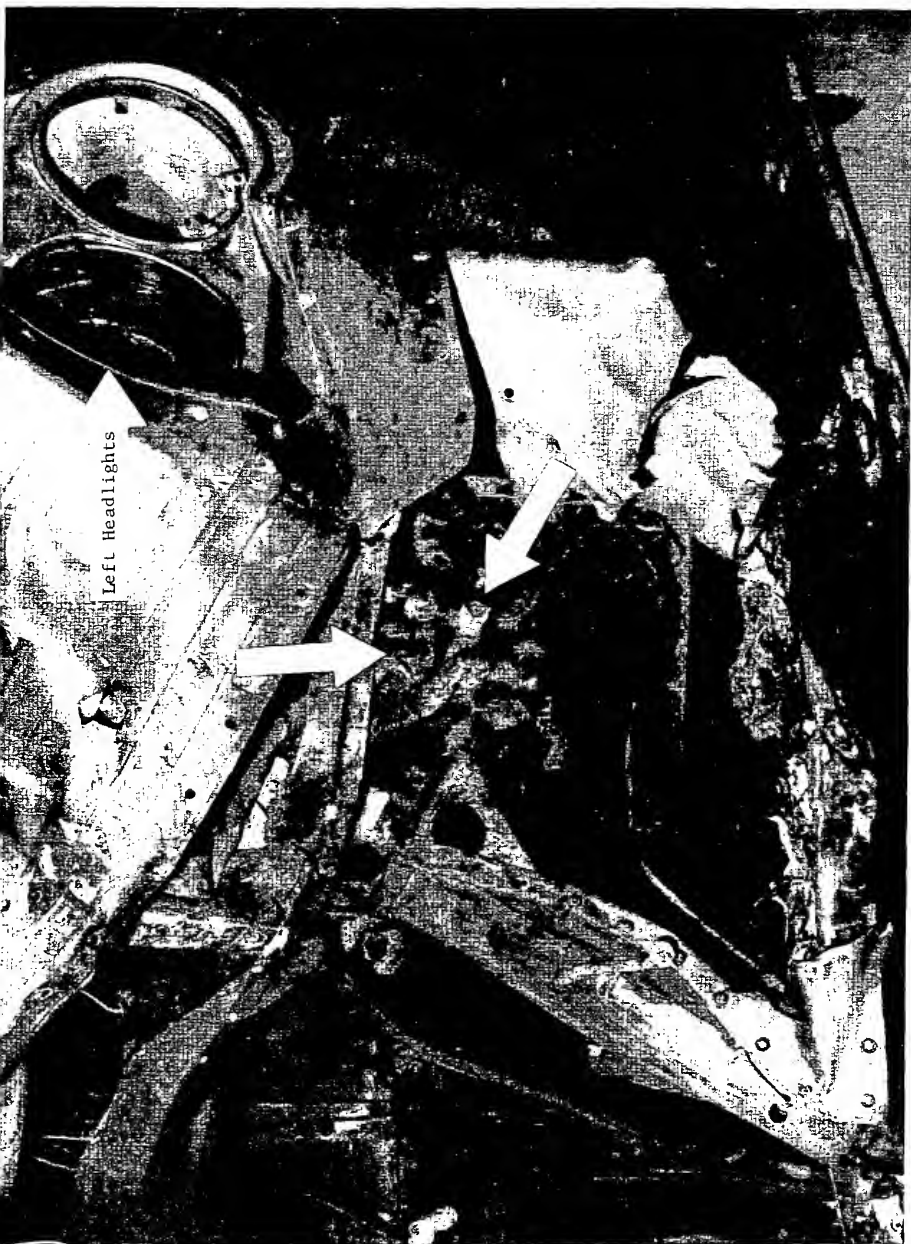
ILLUSTRATION 3

During the collision phase, fire immediately broke out in the front area of the bus, fueled initially by vaporized power-steering oil, and shortly thereafter by diesel fuel. The power-steering oil was discharged from a fitting at the base of the bus steering column which was broken in the collision. (See Illustration 3.) The diesel fuel was sprayed, splashed, and spilled over a large area of the bus, including the baggage and passenger compartments. The fire spread and grew rapidly in intensity.

Fire started in the bus almost immediately upon impact. The fuel source of the initial fire was power-steering fluid under high pressure discharged in a fine mist from a broken fitting at the base of the steering column on the bus. The fluid, #10 lubricating oil, has a flash point of approximately 400° F. when vapors are generated. Due to high torque on the steering, there were probably more than 500 pounds of pressure per square inch generated in the power-steering system at the moment of impact. Such high pressure would cause discharge of the fluid as a fine mist which is highly flammable.

3. The Fire was caused by power-steering oil being discharged under high pressure from a broken fitting damaged by the collision, and

ignited by exposed electrical circuits in the front of the bus. This fire then ignited the diesel oil spilled from the ruptured fuel tank of the bus.

Power steering fluid fitting. Arrows point to severed power steering fluid line.

2. The Safety Board recommends that the Federal Highway Administration, in its development of motor vehicle safety performance standards, review all motor vehicle fuel systems, including diesel fuel; and power steering, and brake systems. Also, in the establishment of crash barrier criteria, full consideration should be given to intrusion factors and flammability of fuels and fluids used in these systems.

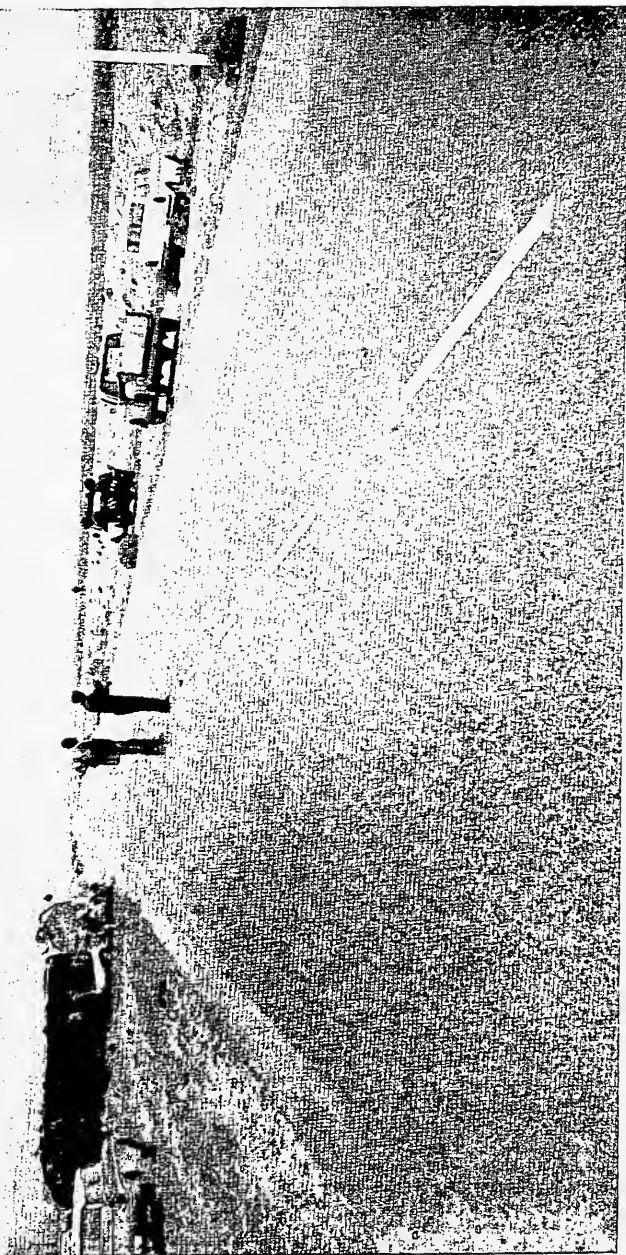
ILLUSTRATION 5

Interstate 15 looking east from accident site. Visibility is without practical limitations

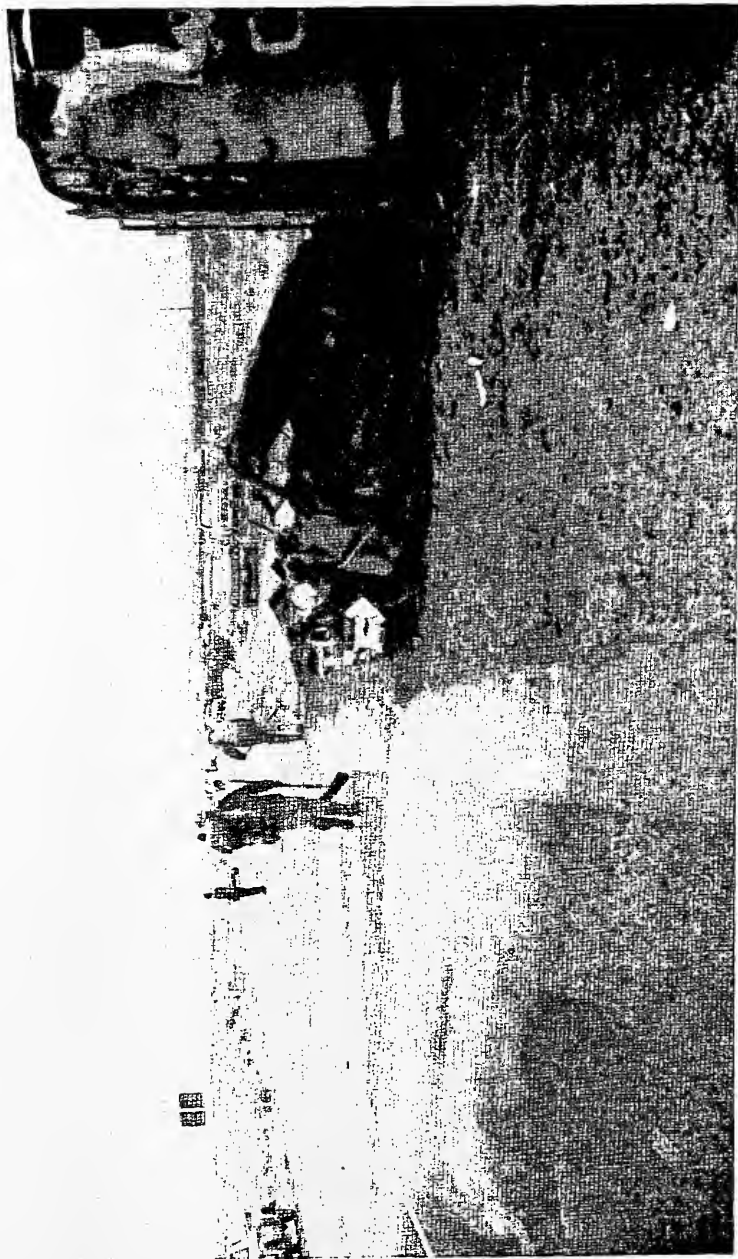
ILLUSTRATION 6

Interstate 15 looking west from accident site. Visibility is without practical limitations.

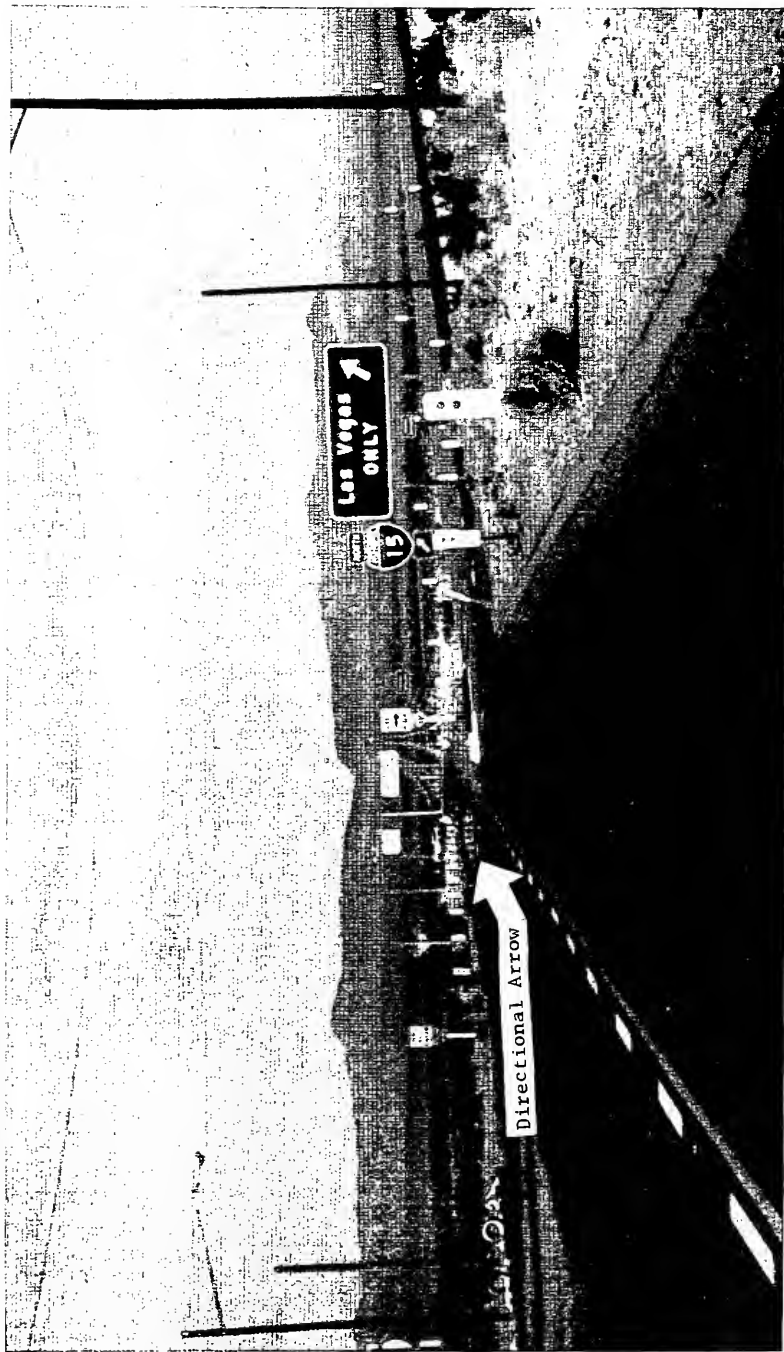
ILLUSTRATION 7

Baker interchange. Entrance to eastbound Interstate 15 (Las Vegas) is on right. Exit from westbound Interstate 15 to Baker is on left. Note Keep Right, Wrong-Way and Do Not Enter signs and centerline pavement markings. A white directional arrow is in place on the roadway pavement.
